## Latin American Operator Protects Casing in Re-Entry Wells

**Location:** Latin America  
**Well Type:** Build-and-Hold Re-Entry Sidetrack  
**Objective:** Casing Protection  
**Solution:** WWT NRPs  
**Results:** Minimal Casing Wear at Sidetrack Point

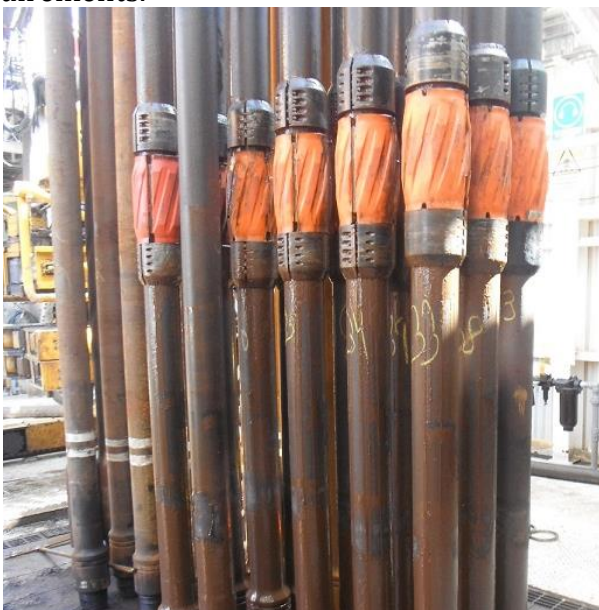
A USIT log indicated only 5-10% wear was measured at the side track point, which protectors covered the entire run. Even with partial coverage, the maximum wear experienced in the 9 7/8" liner was below 14%, well below operator's requirements.

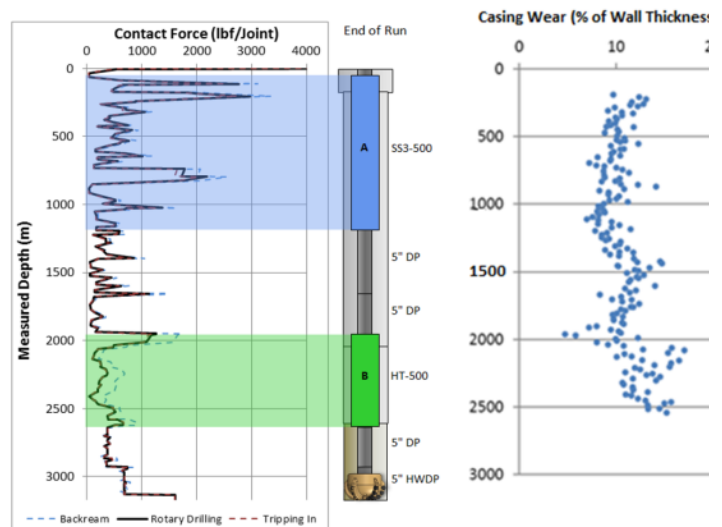
Polishing of tool joints indicates casing protection using NRPs:

With NRPs

No NRPs

WWT Non-Rotating Protectors (NRPs) installed 1.4m (4.6ft) above the tool joint connection created stand-off between the drill pipe and casing. NRPs were installed 1/stand where side forces exceeded 2,500 lbs/jt in the vertical section of the wellbore. Tool joints adjacent to the installed NRPs remained unpolished, indicating successful tool joint standoff.
