# Proven Drillability of WWT NRPs: Full-Scale Testing

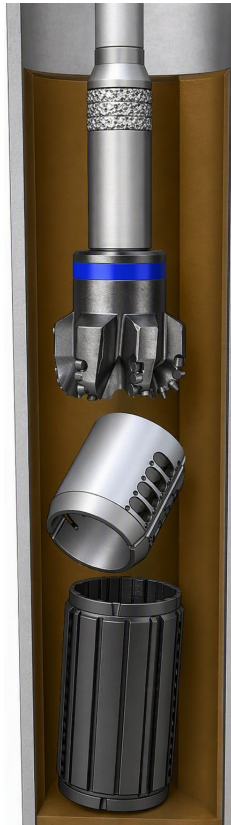
Illustration of  
the S4-400-  
slim-RS and 4"  
slim collar  
inside the hole

A 6-1/8" open-hole was simulated by cementing and then drilling the cement with a 6-1/8" bit. Each NRP and 4" slim collar were then dropped into the hole and drilled using water only. Cement was drilled at an average ROP of 60 ft/hr, while a controlled ROP of 50 ft/hr was maintained when drilling the NRPs. Torque remained consistent in all drilling runs, averaging 3,000–3,500 ft-lb. Some bit cutter wear was observed, which would likely be further reduced when using conventional drilling mud.

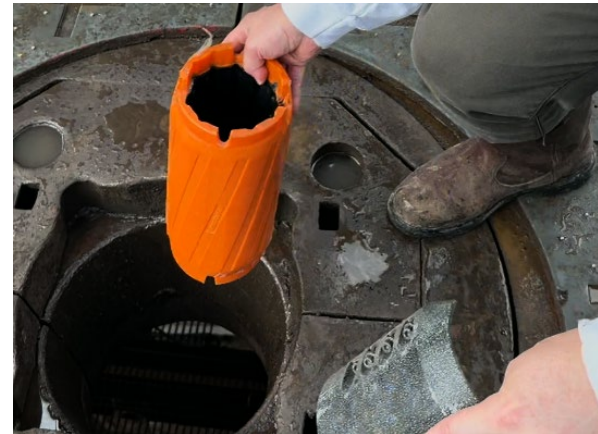
SS3-400-slim and 4" slim collar being  
thrown in the well

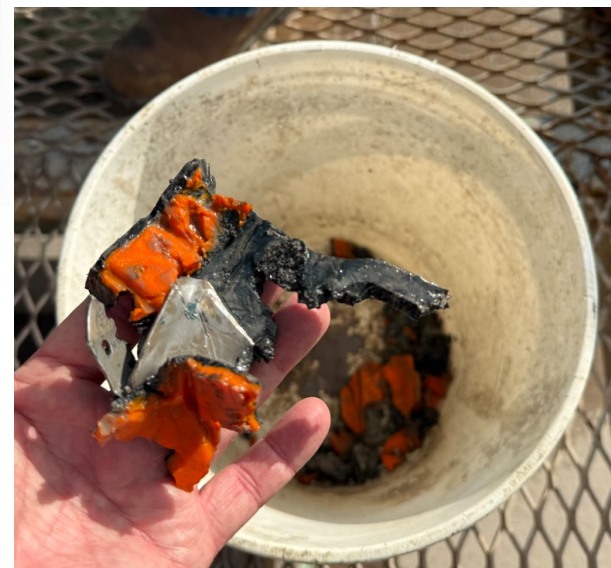
S4-400-slim-RS debris recovered on  
shakers

The results were successful for both NRP models. The NRPs were drilled without issue, and torque stabilized after drilling. The testing, together with 37+ years of field experience, confirms that WWT NRPs are fully drillable. No well has ever been abandoned due to NRP failure.
